## A Record of Repairs to the Leechwell, Totnes

As undertaken by the Leechwell Garden Association and Totnes Town Council

May 2015

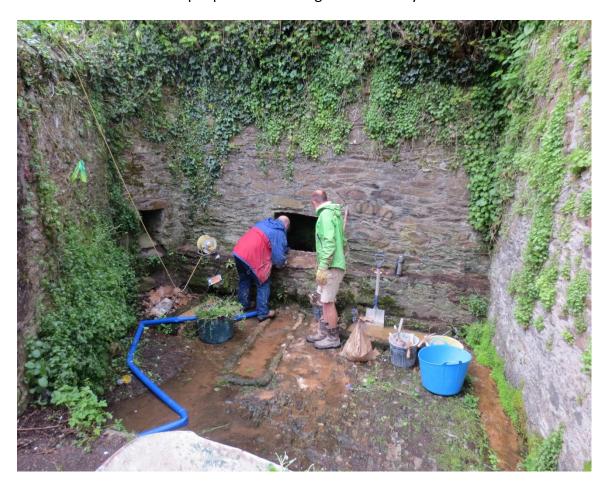
Fig.2 The well overgrown and neglected. Bruce and Will remove the old red clay base.

Bruce and Will removed the old clay puddling and found that it is very shallow, not what we expected, only about 5" deep. The big surprise is that beneath the clay layer is a concrete floor-covering the whole interior area (no idea how thick this is) So, the well is not puddled as everyone thought- it merely has a thin layer of clay laid over the concrete. There is a hole in the concrete, about 2ft square. This is not a constructed hole, but a jagged-edged one, clearly drilled or smashed out after the concrete had set. Two areas of little bubbles are welling up nearby.

The brief of this project is to remove the clay only, so for the time being the concrete is left where it is. Bruce and Will repair in the hole in the concrete and press new white clay on top of it.

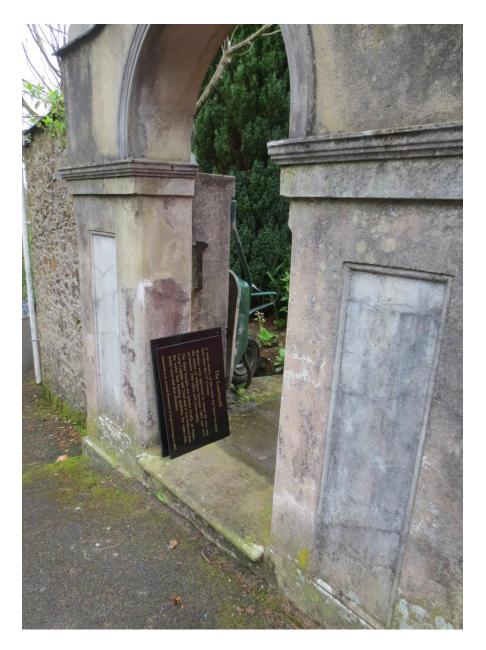
Fig.4 The new information board mounted on marine ply. Thanks to the Mitchells, Bruce was able to link up a power line and store some of his equipment in the garden of Leechwell Cottage, opposite the well.

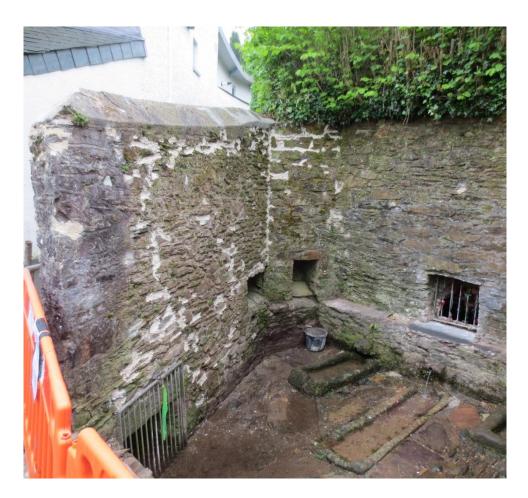
Fig.5 Caught just in time? Substantial repairs were needed to the left hand wall, probably the most recently built element of the well.

A lot of work was needed on this wall. A chunky piece of root (buddleia?) was embedded in the capping, which looked very unstable once the foliage was removed. Bruce plans one more day of work to complete on Monday.

Today was about repairs to the stonework using the Cornish lime, Chard sand and Sussex brickdust mix as specified by Oliver. This looked very bright when it went on the wall but will mellow to a sand colour quite quickly. It will be protected by hessian over the weekend. Bruce has removed the graffiti inside the well but there is still some on the nearby wall of the lane.

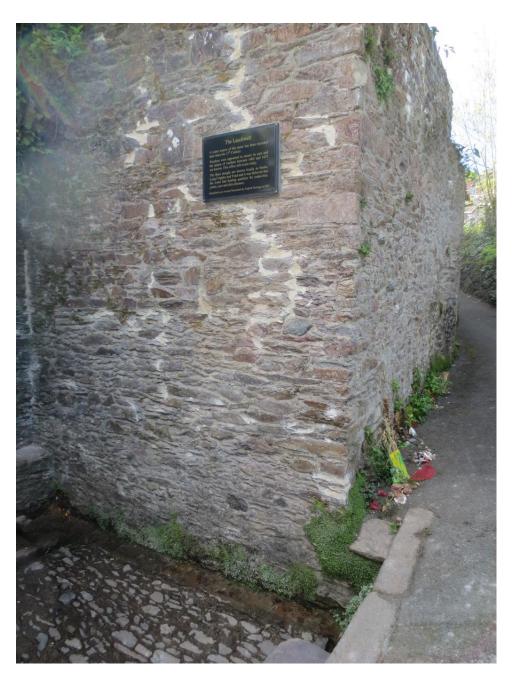
Fig.6 The board is unobtrusive but legible from below, the text can be found in Section 6. Hopefully, the board will be out of reach of graffiti artists. Some large cracks in the wall have been repaired. A depressed channel drains water along the base of the wall from the trough called 'Toad'.

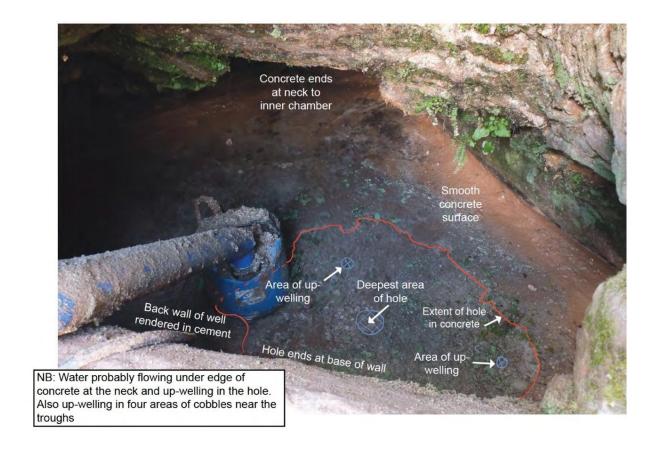
Fig.9 What was revealed when the clay, silt and debris were removed from the outer chamber

This revealed a smooth cement floor with an irregular hole in it, 18" to 2ft square. The hole is off centre towards the right and closer to the front wall. There is a deeper area in the centre of the hole, up to 18" deep. There are two areas of up-welling, these were noticed in 1996 when the well was last repaired. It was said at the time that the well was lined with tarmac.

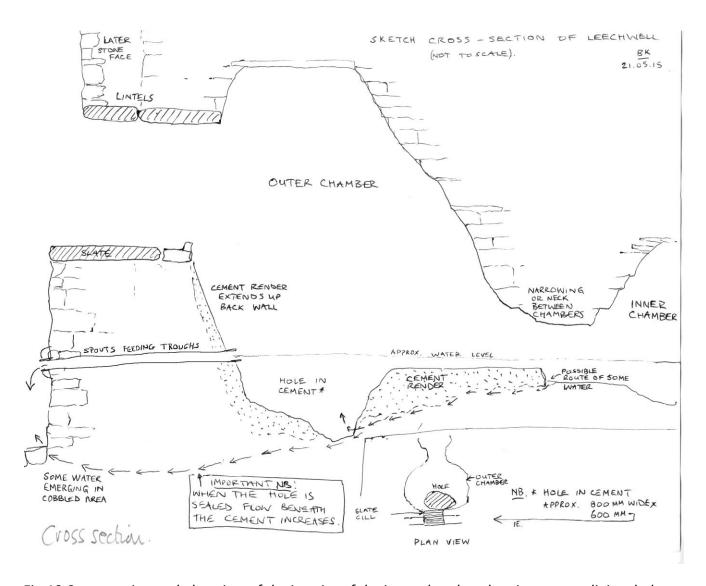
Fig. 10 Cross-section and plan view of the interior of the inner chamber showing cement lining, hole, water level and position of spouts.

The cement may be at least 5" thick and extends up to sides of chamber and the back wall beneath the spouts. The centre of the hole may be 18"- 2ft deep and has areas of upwelling water. The water level in relation to the spouts is crucial- the clay helps to raise the water level above the concrete, but there is little leeway as the concrete is set just above the level of the floor of the inner chamber, the source of the water. When the hole is sealed the water ceases to flow.

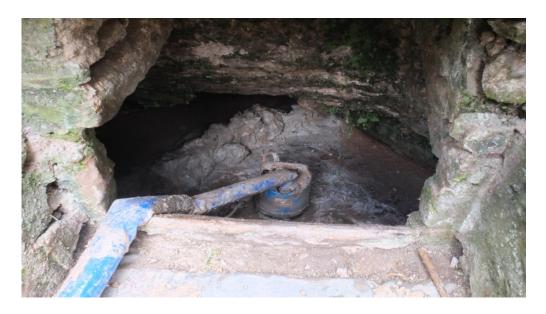
Fig.11 A dam was formed and a pump was used to remove as much water as possible.

Fig. 11 shows how the clay dam holds back the water so that repairs can take place. Two areas of upwelling were located. Hole sealed with stone, hydraulic lime NHL3 and Chard sand (ratio 1:2:5)

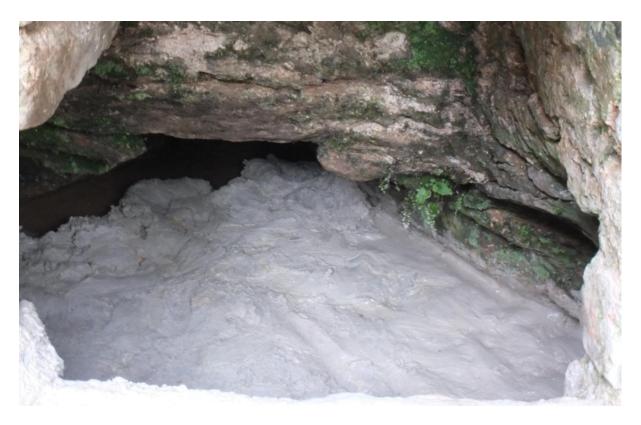
Fig.13 Working backwards towards the neck and channel with the clay. The shallow opening to the inner chamber can be clearly seen. The interior is in good condition, only a few small repairs were needed.

Once the hole was sealed, grey ball clay from Ringslade Quarry (soaked and worked to make pliable) was used to puddle the base and repairs, to seal leaks and to raise the water level behind the spouts.

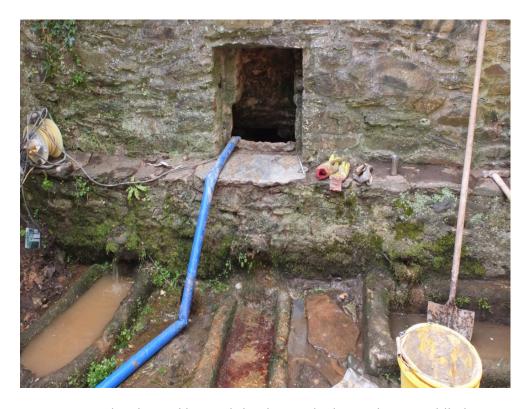
Fig.14 The channel beyond the dam is the last to be re-puddled.

The water flow through the left hand spout (which is fractionally higher than the other two) initially increased due to pressure of the dam but was lost as the dam was removed. However, the following day the water flow through all three spouts had almost gone and the flow through the cobbles increased. As a result, Oliver and Bruce decided to reinstate the hole in the concrete and make channels in the clay to bring water to each spout, at which point the flow through the spouts quickly increased.

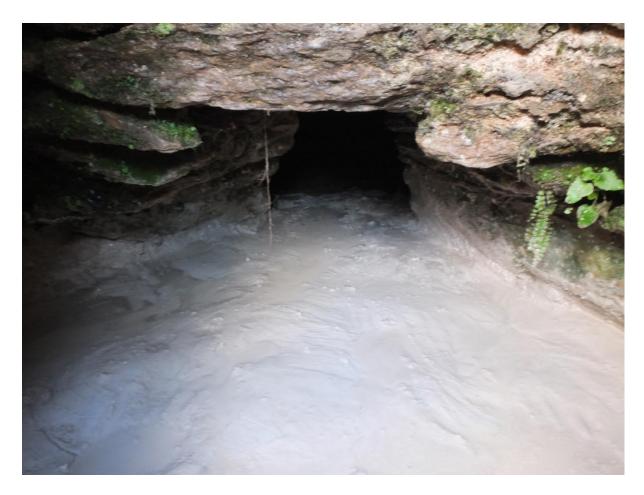
Fig.15 Newly re-puddled interior complete.

This shows the clay smoothed out and water flowing in from the back entry to the inner chamber. The stonework dividing the two chambers is generally in good condition. Bruce wonders if the inner chamber is possibly not as natural as originally thought... one more mystery to ponder over?
