## A Record of Repairs to the Leechwell, Totnes

As undertaken by the Leechwell Garden Association and Totnes Town Council

May 2015

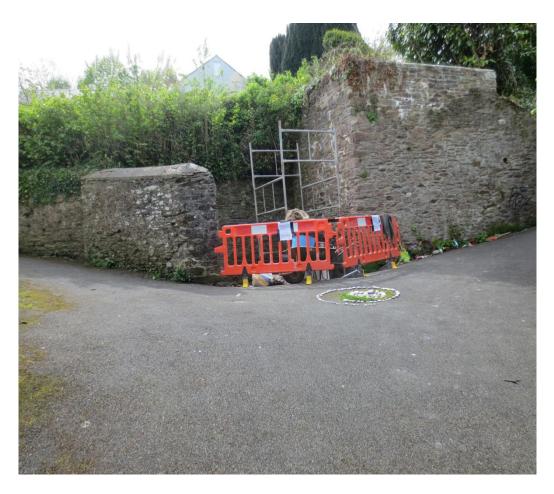
A much-visited and much-loved site in Totnes the well has nevertheless suffered years of neglect. The well was last repaired in 1996 when it was said that a layer of tarmac had been removed from the outer chamber and the base re-puddled with clay. By 2013, water was seeping away through the floor of the outer chamber so that the water supply to the granite troughs was almost non-existent, the cobbled basin was clogged with sludge, grass and stagnant water, ivy, buddleia and other foliage was growing in the outer walls and the stonework and wall capping was badly cracked. The information board had been lost many years ago.

Fig.1 View from Leechwell Lane. The Lane divides here, leading to Maudlin Road on the left and to the Kingsbridge Inn on the right. The garden of Westhill House lies above the back wall of the well. The pebble spiral was created during earlier May celebrations here.

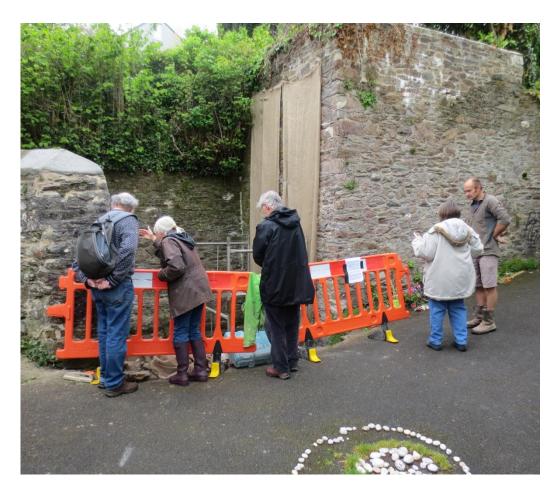
Fig.3 Meeting at the well. Left to right: James Bellchambers, Shirley Prendergast, David Martin, Pruw Boswell, Bruce Kirby. Dave Mitchell is taking the photograph. (The hessian protecting the new lime mortar is still in place)

After discussion it is decided that Bruce will complete the job as agreed- ie fill cracked stonework and capping, clear silt and debris, clean the cobbles and put up the new notice board. If the water continues to flow through the spouts (two fairly strongly) that is a great improvement. The whole area will function better, look better and be more secure. Short of removing the concrete little more can be done for now.

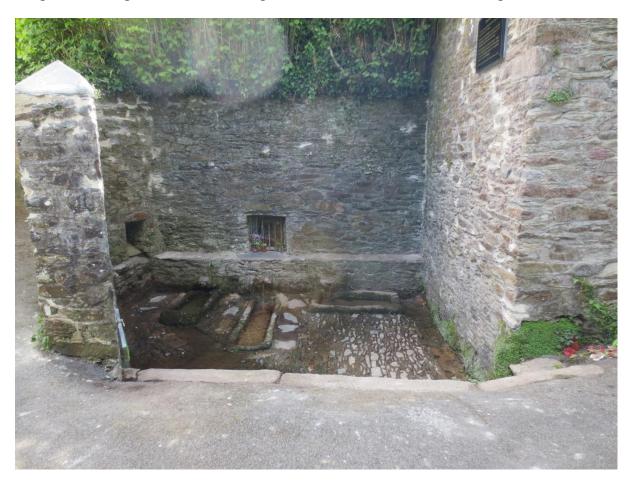
The well now looks rather bare and no doubt some people will be disappointed with this. But in time the ivy and other foliage will grow back and soften the look of the stone structure. The water is flowing through all three spouts - strongly through two - and the sound of splashing is very

welcome, it can be heard some distance away and makes the whole area come alive. Rather than silt, grass and stagnant slime, the troughs are clean and full of fresh running water.

Fig. 7 This is a glimpse of the well as the living place it must once have been: a cared-for and highly valued resource with a powerful atmosphere of spirit of place, reflecting the well's uniqueness and antiquity as one of the most significant in Devon (according to Faull, 2005).

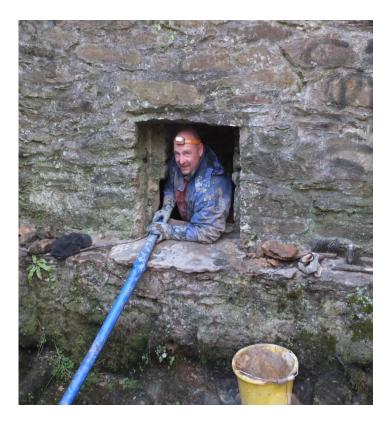
Fig. 8 Day 1: Will manages to squeeze inside the outer chamber.

This revealed a smooth cement floor with an irregular hole in it, 18" to 2ft square. The hole is off centre towards the right and closer to the front wall. There is a deeper area in the centre of the hole, up to 18" deep. There are two areas of up-welling, these were noticed in 1996 when the well was last repaired. It was said at the time that the well was lined with tarmac.

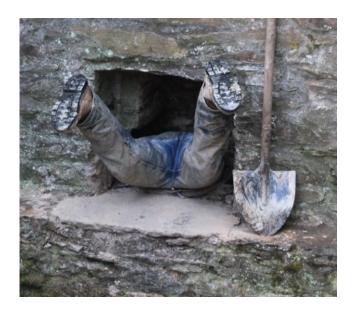
Fig.12 The Webb technique!

Once the hole was sealed, grey ball clay from Ringslade Quarry (soaked and worked to make pliable) was used to puddle the base and repairs, to seal leaks and to raise the water level behind the spouts.
